PASSAIC RIVER BASIN
STONE HOUSE BROOK, MORRIS COUNTY
NEW JERSEY

LOWER KAKEOUT DAM NJ 00822

PHASE 1 INSPECTION REPORT NATIONAL DAM SAFETY PROGRAM

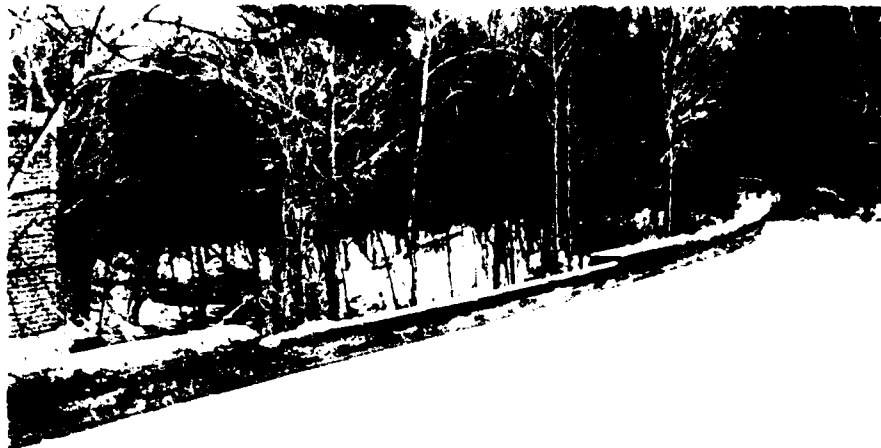
Some spalling could be observed along the upstream face of the dam between the crest and the water level, however, it did not appear to be as severe as the spalling on the downstream side. However, there were some points where it was 3 to 4 inches deep and the spalling tended to run along horizontal lines. There was one location on the downstream face approximately 15 feet to the right of the outlet structure where some ice was emerging from the downstream face. This indicated some very slow leakage. The point where the ice was emerging is a point where there was considerable incrustation and possible exudation.

PHOTO 1
UPSTREAM SIDE OF DAM

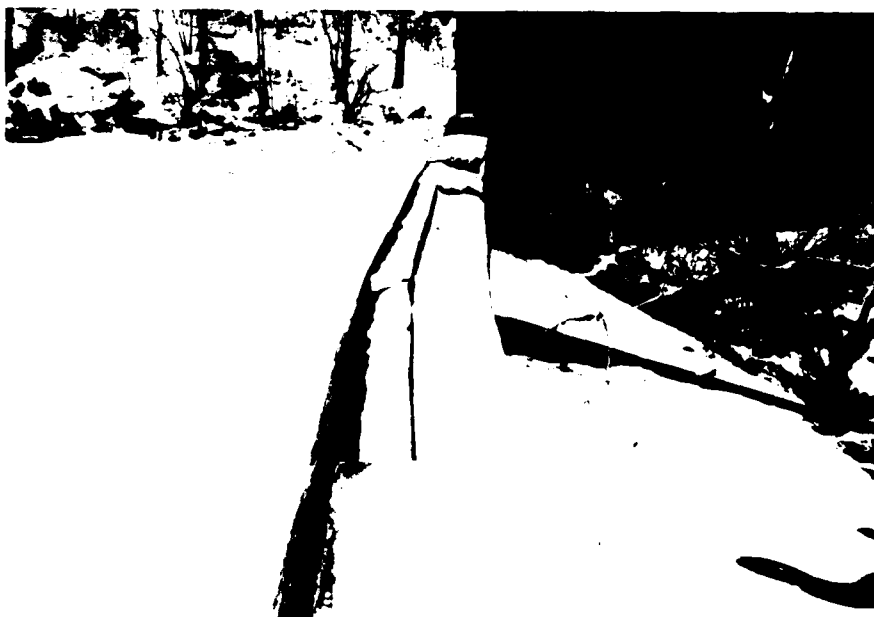
PHOTO 2
PRIMARY SPILLOVER SECTION OF DAM

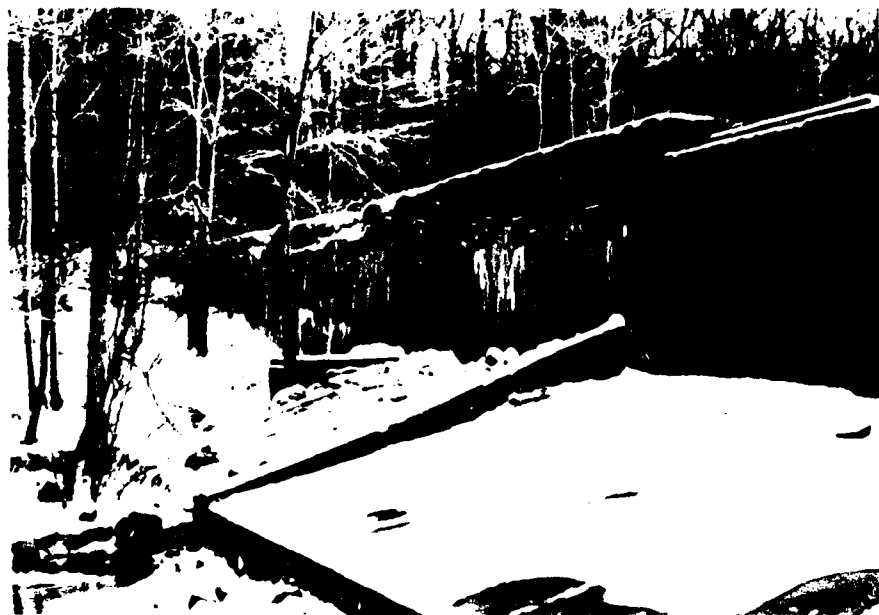
No structural cracking or unusual movement of the dam was observed. However, severe surface deterioration of the concrete was noted. The downstream face from the spillway to the right end of the dam was spalled and cracked. The spalls were as deep as 0.6 feet. The crest on its downstream side was severely deteriorated from spalling and erosion from approximately the outlet works to the right end of the dam. The crest was also deteriorated for a distance of approximately 15 feet immediately to the left of the spillway.

PHOTO 4
DOWNSTREAM SIDE OF DAM - RIGHT PORTION

- 1) The outlet works should be investigated with respect to operational adequacy and then restored to proper operational condition.
- 2) All spalled, cracked and otherwise deteriorated surfaces of the dam should be thoroughly repaired.

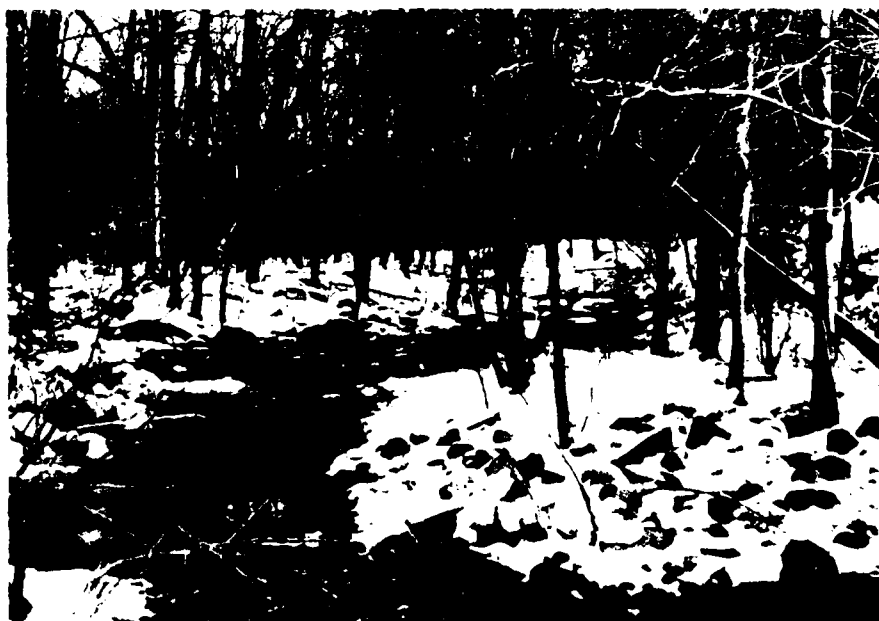
Downstream from the spillway apron, a small scoured section containing large boulders and serving a stilling basin was observed.

PHOTO 10
DOWNSTREAM CHANNEL
